BEHAVIOUR OF REACTIVE SANDS IN CONCRETE. A CASE STUDY

Juan J. Berezosky⁽¹⁾, Leticia Lescano^(2,3), Francisco Locati⁽⁴⁾, Pedro J. Maiza⁽²⁾ and Silvina A. Marfil^{(2,3)*}

The concrete of a ring road in the city of Bahía Blanca (Province of Buenos Aires, Argentina) has deteriorated despite ongoing repairs.

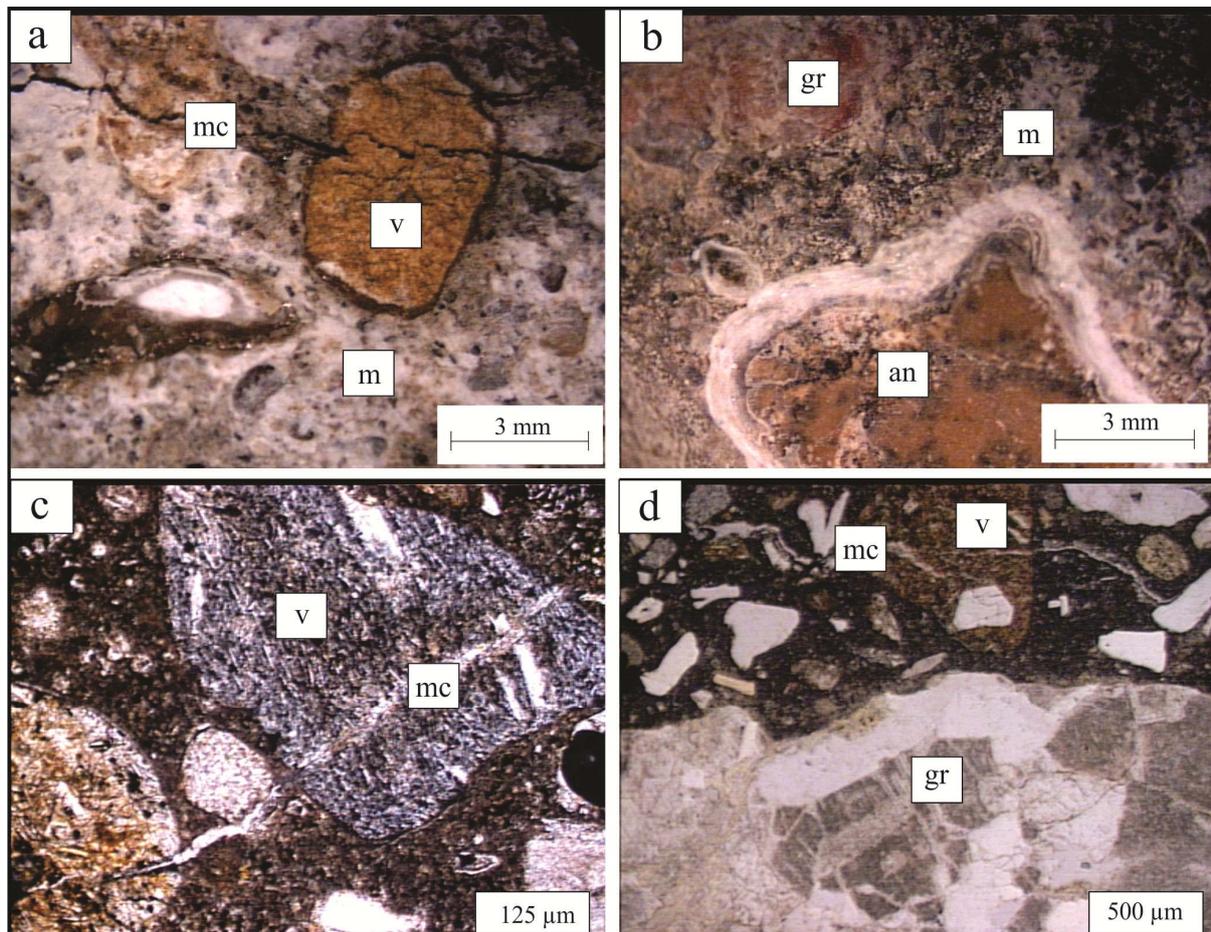
Figure 1a shows a microcrack affecting two vulcanite particles of the fine aggregate. They are partially covered with reaction products. The mortar is completely altered, and its texture and components cannot be identified. Figure 1b shows an andesite particle with signs of reaction. The peripheral zones have been replaced by secondary minerals deposited in the weakness zones, especially the matrix. The mortar is coated with reaction products. The upper left angle of the photomicrograph shows a granitic particle of the coarse aggregate without any signs of alteration.

and rarely affect the lithic components of the fine aggregate. Then, there are longer and thicker discontinuous cracks, which are sometimes ramified, partially filled with either particulate material or calcite. They also affect the fine aggregate components, especially volcanic rocks with glassy matrices (Figure 1c). Figure 1d shows a cracked sand particle (volcanic rock) and a particle of the granitic rock that forms the coarse aggregate with no signs of reaction.

Figure 1: Original concrete. a: Microcrack (mc) affecting two vulcanite particles (v) of the fine aggregate. The mortar (m) is completely altered. b: Andesite (an) with signs of reaction. The mortar (m) is coated with reaction products, while the coarse granitic aggregate (gr) does not show reaction boundaries. c: Microcrack (mc) affecting the mortar and two fine aggregate particles (v). d: Cracked vulcanite (v) and particle of a granitic rock (gr) that forms the coarse aggregate with no signs of reaction.

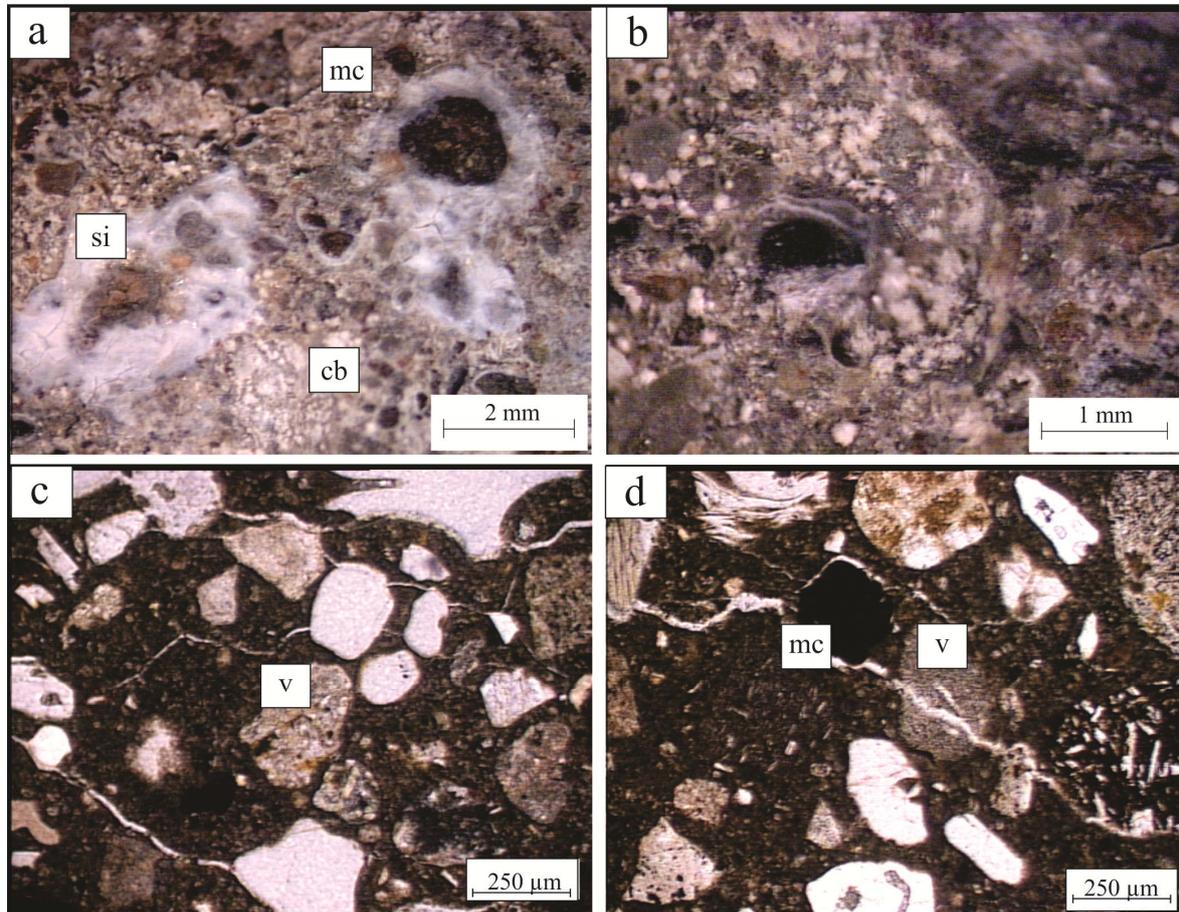
Figure 2a shows an intense reaction process, which developed mainly on the fine aggregate components. The siliceous exudate comes from reactive particles, mainly glassy vulcanites, and then extends towards the matrix. The loss of water causes mass contraction giving rise to microcracks. The mortar shows intense carbonation, mainly in the periphery and inside concrete voids.

Figure 2b depicts a partly massive “rosette-like” reaction material.

Figure 2c shows the severely cracked mortar and the composition of sand, where volcanic rocks prevail, as well as very unweathered glass fragments. Another zone with a high content of volcanic rocks that are also cracked is depicted in Figure 2d.

Figure 2: Repair concrete. a: Siliceous reaction material (si) on a reactive particle. A microcrack (mc) on the carbonated mortar (cb) can be seen. b: Massive rosette-like product in the mortar. c and d: Microcracks affecting volcanic rocks (v) of the fine aggregate.

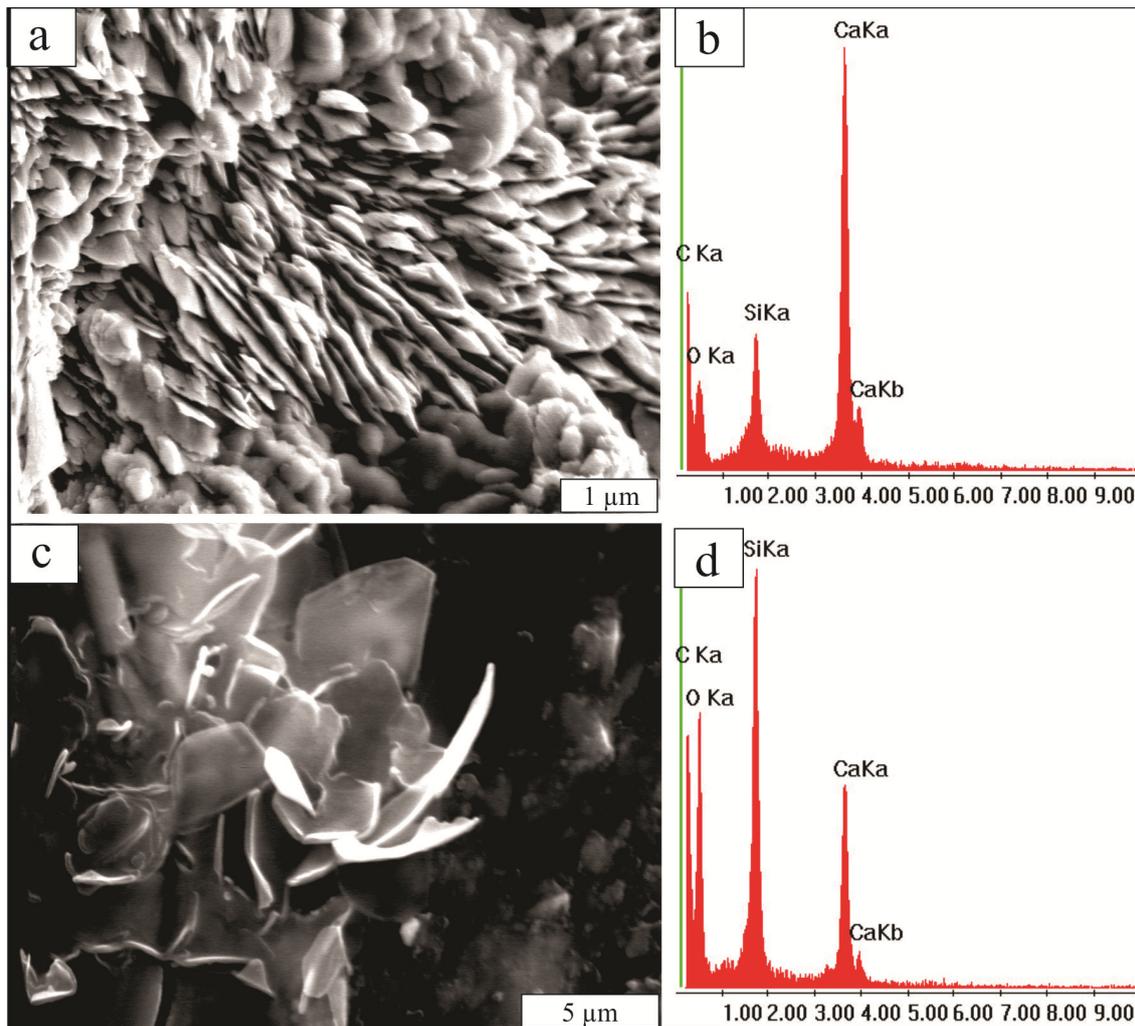
The reaction material from both pavements was separated under a stereomicroscope to be analysed by SEM. Although different morphologies were observed, it consists almost entirely of portlandite, calcite and calcium silicates with subordinate ettringite. The morphology and composition of laminar silicates associated with the ASR are shown in Figure 3a-d. The reaction products identified are very rich in calcium and without Na and K.

Figure 3: SEM. a: Morphology of the material that developed on the concrete surface.
b: EDS of the material observed in 3a. c: Products associated with the ASR.
d: EDS of the material shown in c.

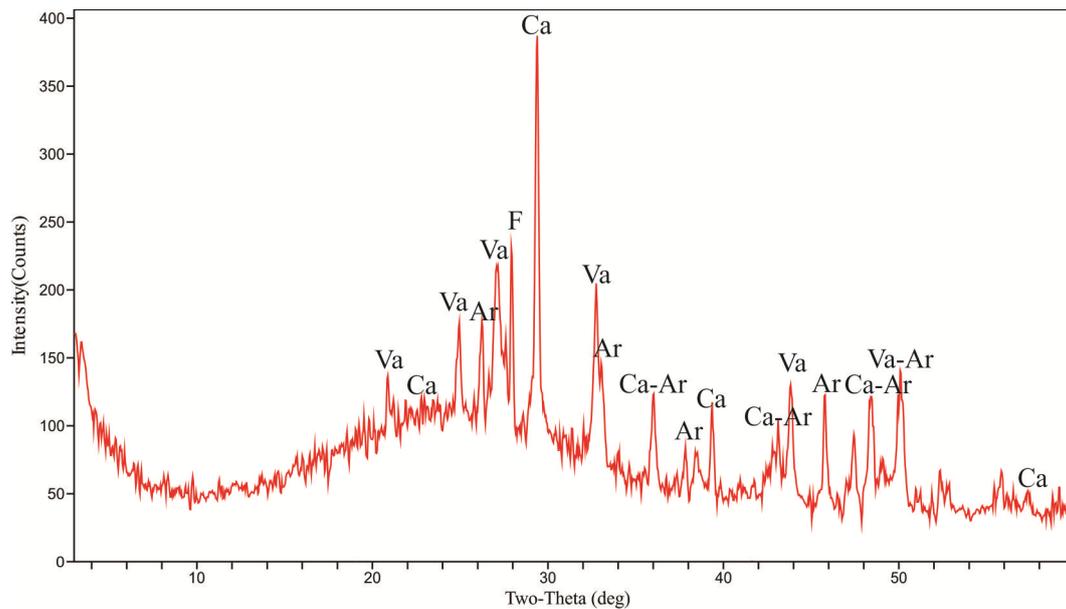
The material found on the original concrete surface, in the aggregate–mortar contact areas and inside entrained air voids was separated. Calcium carbonates (calcite, vaterite and aragonite) were identified (Figure 4). The background rise in the diffraction pattern between 20 and 30 ° (2θ) is due to the presence of amorphous material. As the reaction products (calcium silicates) and ettringite observed by SEM have very low crystallinity, they could not be detected by this method. Feldspar belongs to the fine aggregate.

Figure 4: XRD of reaction products. Va: vaterite, Ca: calcite, Ar: aragonite. F: feldspar.
