ASR Induced Blow-up in an Urban Concrete Pavement (Bahía Blanca–Argentina)

The urban pavement at 600 Catamarca street in the city of Bahía Blanca (Argentina) burst lifting the concrete slabs at the contraction joint. The aim of this study was to investigate the causes that lead to the concrete deterioration. Aggregate constituent materials, their mineralogy, textures, condition of the paste and the aggregate–mortar interface were determined by a petrographic analysis of the concrete. A petrographic optical microscope, X-ray diffraction (XRD), scanning electron microscope (SEM) and energy dispersive X-ray (EDX) was used. Abundant ettringite development was noted both inside cavities and on the concrete surface. Its occurrence was confirmed by XRD and EDX analyzes. The aggregate deleterious constituents were mainly glassy vulcanites and volcanic glass, generally altered to argillaceous minerals of the montmorillonite group and strained quartz, with undulatory extinction. It was concluded that pavement deterioration was due to the alkali–silica reaction (ASR).

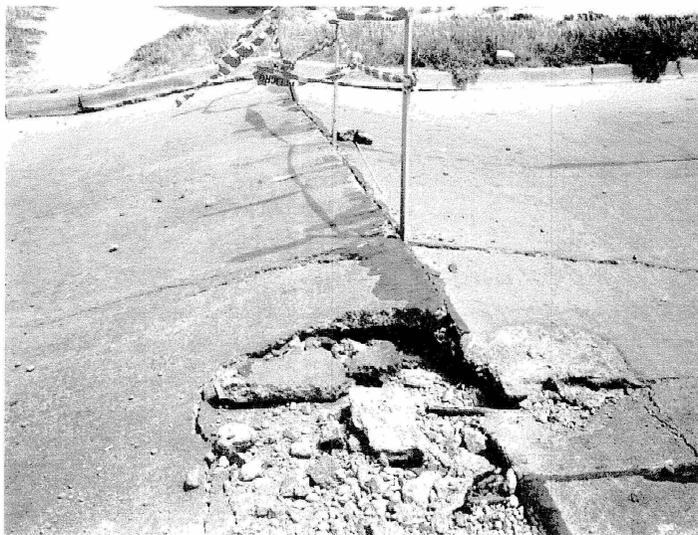
FIGURE 1 View of the deteriorated pavement at 600 Catamarca street, after the burst.

Slabs were lifted over 0.3 m and dislodged from the ground, causing extensive cracking that led to the displacement of large fragments of material. The condition of the pavement is shown in Fig. 1.

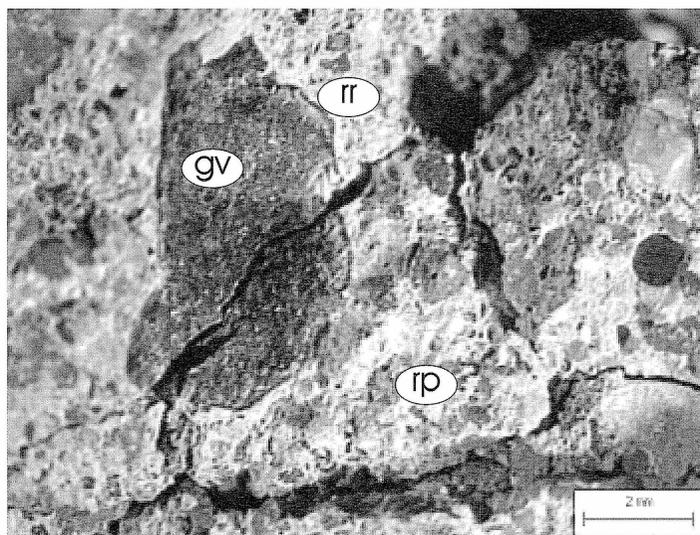
The pavement exhibited a high degree of deterioration from the extensive cracking that affected the mortar and reactive aggregate particles (Fig. 2). There was a white massive material inside the cracks. Most of the deleterious materials exhibited reaction rims, in some

case lined with a whitish material. Other particles had undergone an advanced reaction process that made them brittle with marked zeolitization and argillization.

FIGURE 2 Extensive cracking affecting the mortar and reactive particles (glassy vulcanites: gv), with development of reaction products (rp) and reaction rims (rr).

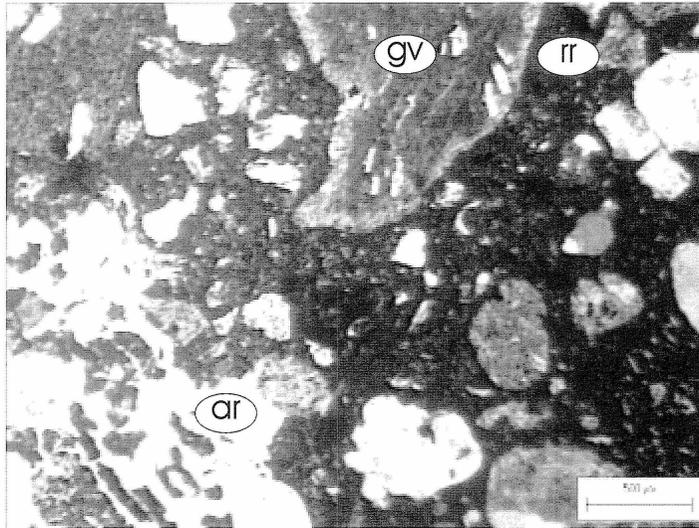
FIGURE 3 Thin section of concrete pavement. Development of reaction rims (rr) at glassy vulcanite particles (gv) and paste argillization (ar) with obliteration of the aggregate original texture.

The mortar was cracked; the cracks had traversed across in the paste and deleterious aggregates. Figure 3 illustrates the aggregate and paste, showing reaction rims on the boundaries of glassy vulcanite particles. A fraction of the mortar was severely cracked as a consequence of the development of an argillization process from the glass of vulcanite particles.

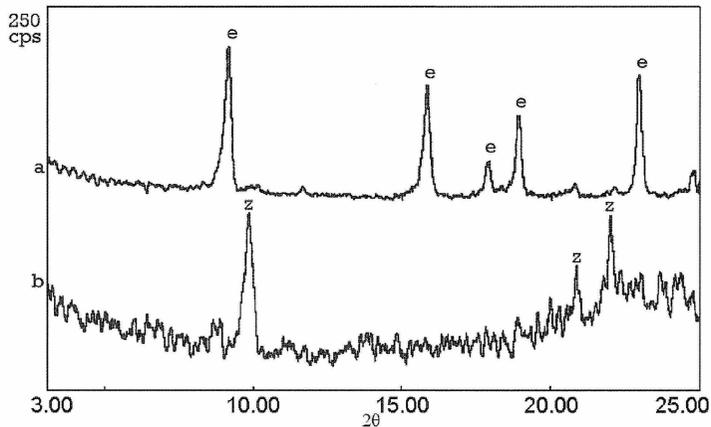
The material from inside the cracks, reaction rims and surfaces of the reactive aggregates was analyzed by XRD. A zeolite of the clinoptilolite–heulandite ($\text{KNa}_2\text{Ca}_2(\text{Si}_{29}\text{Al}_7)\text{O}_{72}\cdot 24\text{H}_2\text{O}$), (ICDD 39-1383) group was identified as the reaction product (Fig. 4(a)). This material presented the highest intensity of reflection at 8.9 \AA and could be easily discriminated from ettringite ($\text{Ca}_6\text{Al}_2(\text{SO}_4)_3(\text{OH})_{12}\cdot 26\text{H}_2\text{O}$), which had the characteristic reflection at 9.7 \AA , as shown in Fig. 4(b). The latter occurred mainly inside cavities of air voids and on the deteriorated concrete surface.

FIGURE 4 XRD of the reaction products. (a) Ettringite (e). (b) Zeolite (z). Their spectra show clear differences.

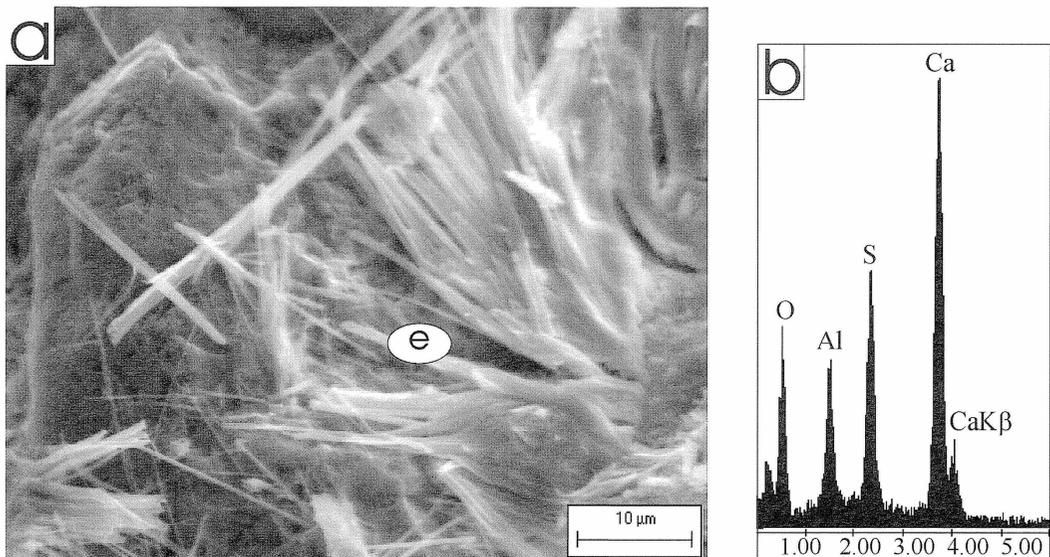
the crystals is shown in Fig. 5(a). The EDX analysis (Fig. 5(b)) revealed the presence of S, Al, O and Ca, in proportions attributed to be ettringite.

FIGURE 5 (a) Fibrous crystals that developed in the deteriorated concrete, identified as ettringite (e) by XRD. (b) EDAX of the material shown in 5(a).

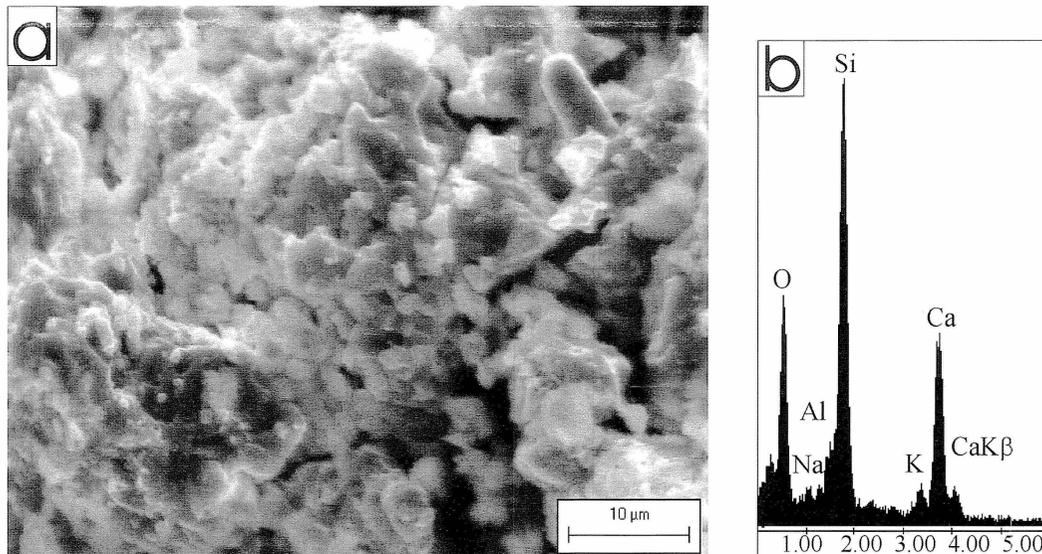
Figure 6(a) illustrates the reaction product from the deleterious aggregates. It developed as reaction rims and inside microcracks. Figure 6(b) gives its chemical composition determined by EDX (Si, Al, O, Ca, Na and K), which was attributed to zeolite identified as clinoptilolite by XRD.

FIGURE 6 (a) Reaction product that developed from the reactive aggregates, identified as clinoptilolite by XRD. (b) EDAX of the material shown in (a).
